EXHIBIT B

DRAFT

Re: 2008 Nissan Altima S #1N4AL21E38N450036, Giancardo Guidoi

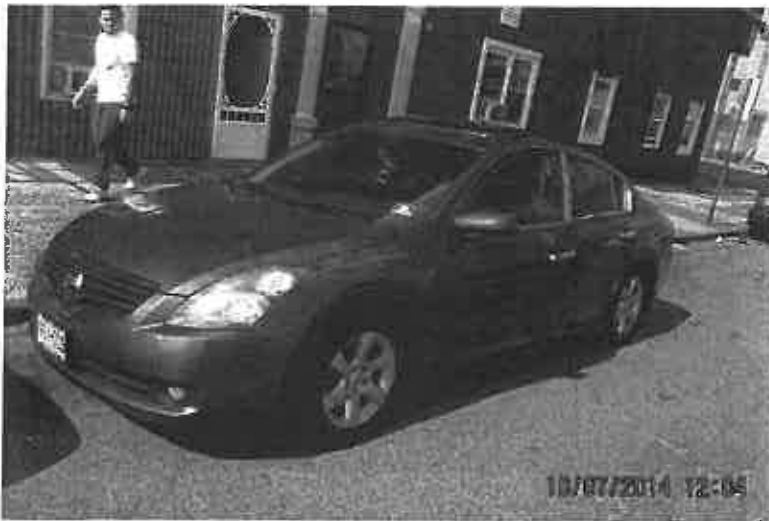
The subject vehicle is shown in the above photo. It is a 2008 Nissan Altima convertible 107,030 miles on the odometer on the date of my inspection. The current Kelley Blue Book value is \$7,167.00 for an identical Nissan in fair condition and without the history of collision damage.

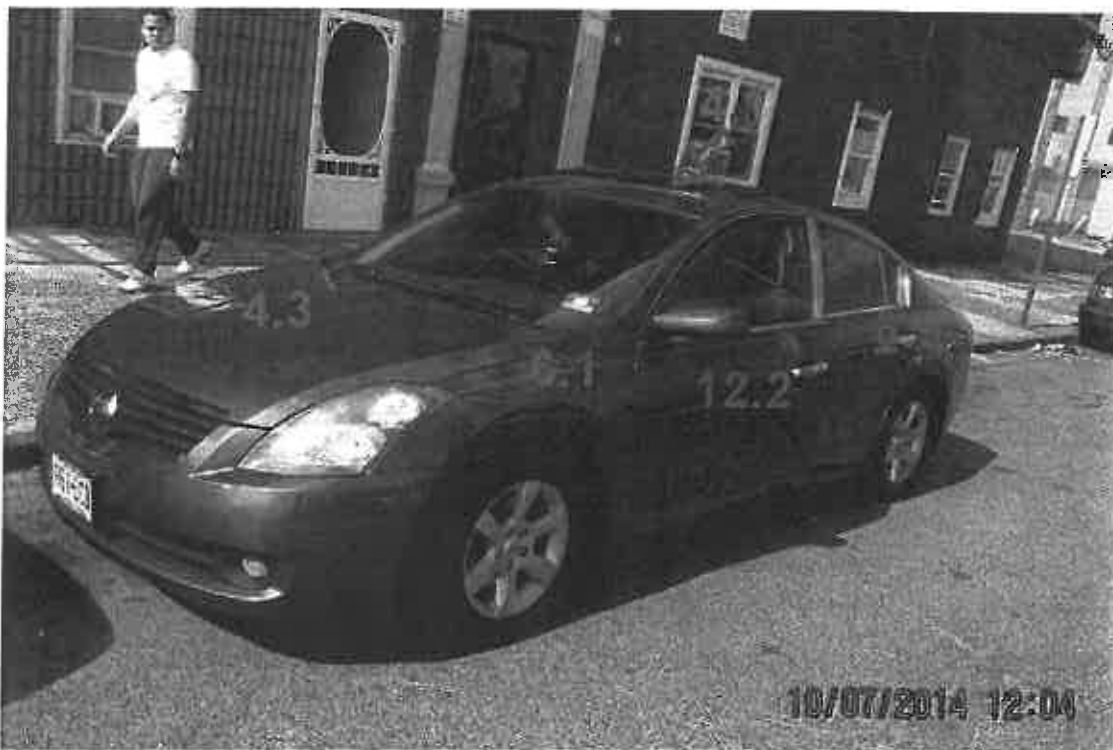
The left side body panels paint film thickness is shown in the above image. One will note the inconsistency in the readings based on the fact there were body repairs and repainting on the left front door and quarter panel. One will note the inconsistency of the readings, an obvious indicator to a dealer conducting a pre-sale inspection for a vehicle being retailed to the public. There is an issue of durability of non-factory finishes as they have over the years been prone to failures due to inconsistency in technician training, facilities and equipment

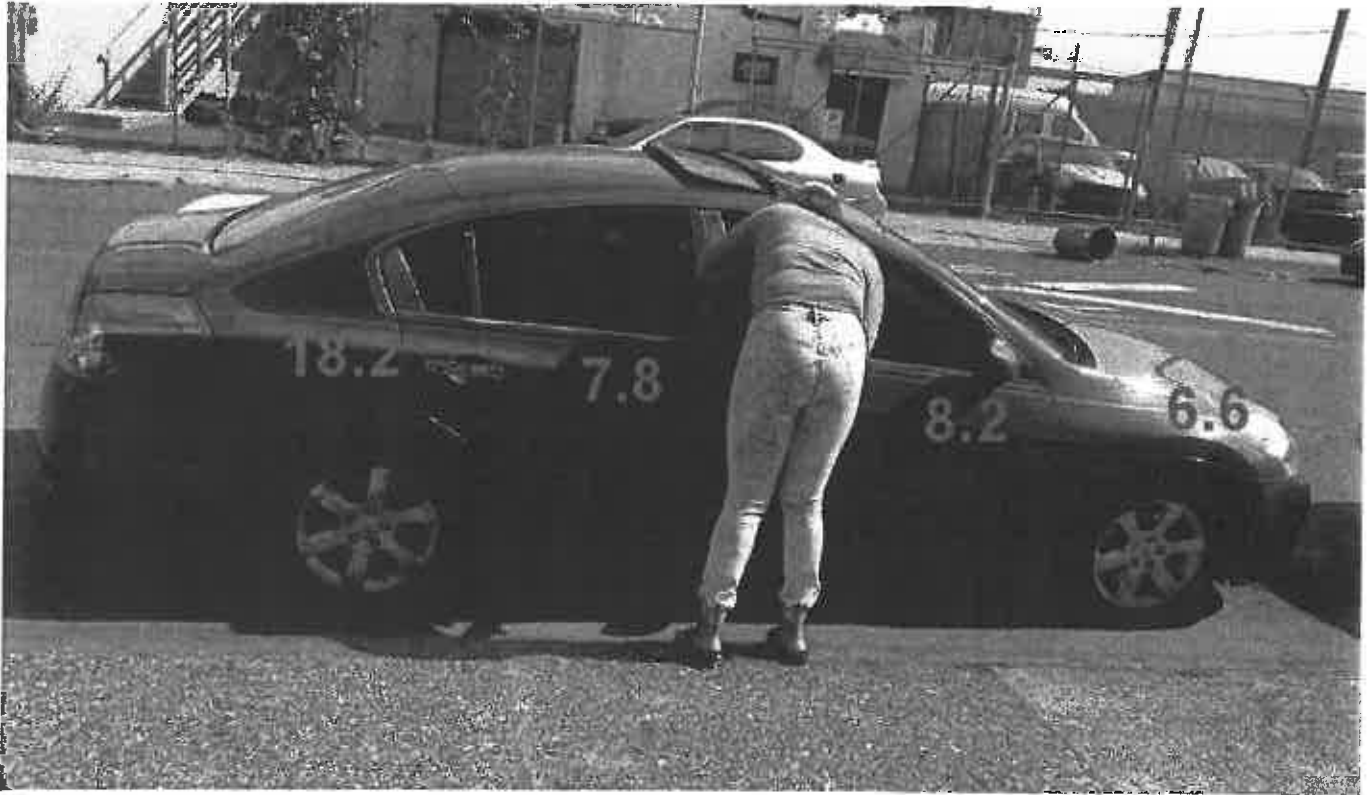
The right side body panels paint film thickness is shown in the above image. One will note the inconsistency of the readings, an obvious indicator to a dealer conducting a pre-sale inspection for a vehicle being retailed to the public. There is an issue of durability of non-factory finishes as they have over the years been prone to failures due to inconsistency in technician training, facilities and equipment. Checking paint film thickness is a standard and simple procedure in the auto trade. This is an obvious item which any person in the automotive profession would have noticed and would have been uncovered in a standard presale inspection by a dealer selling vehicles in the retail market.

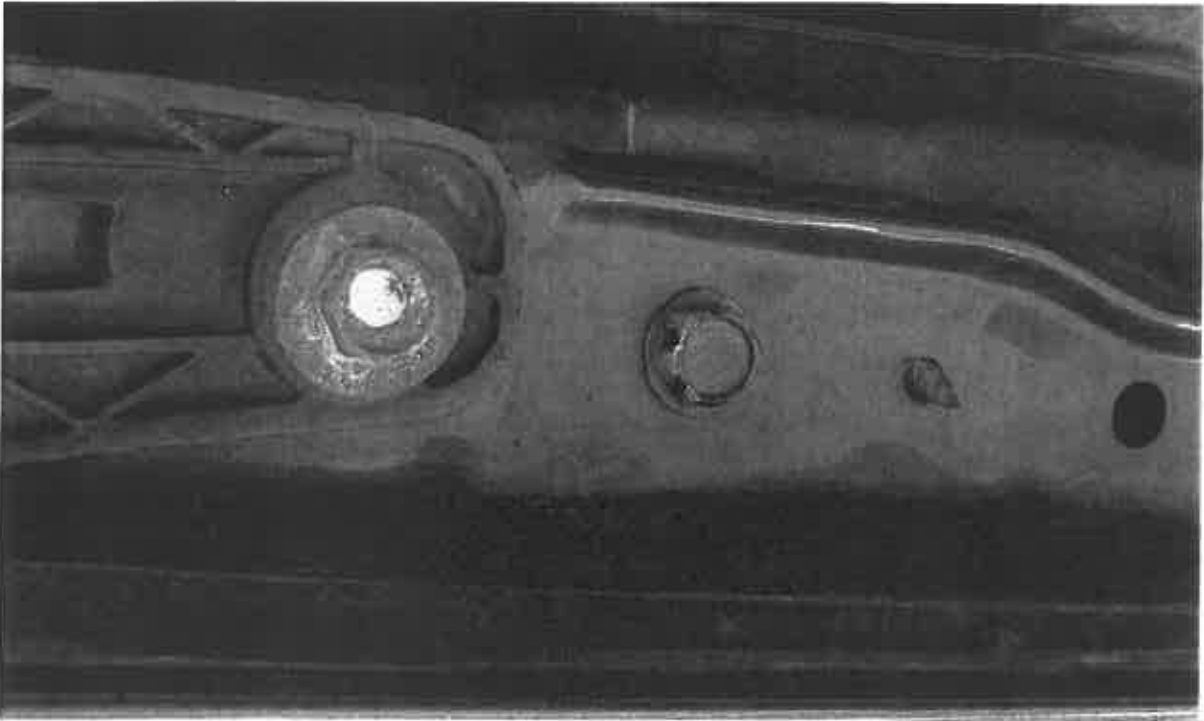
The above photo shows the left fender forward bolt with the distinctive tool marks of collision damage and repairs. Anyone in the industry would have seen this and a conscientious dealer would have investigated further.

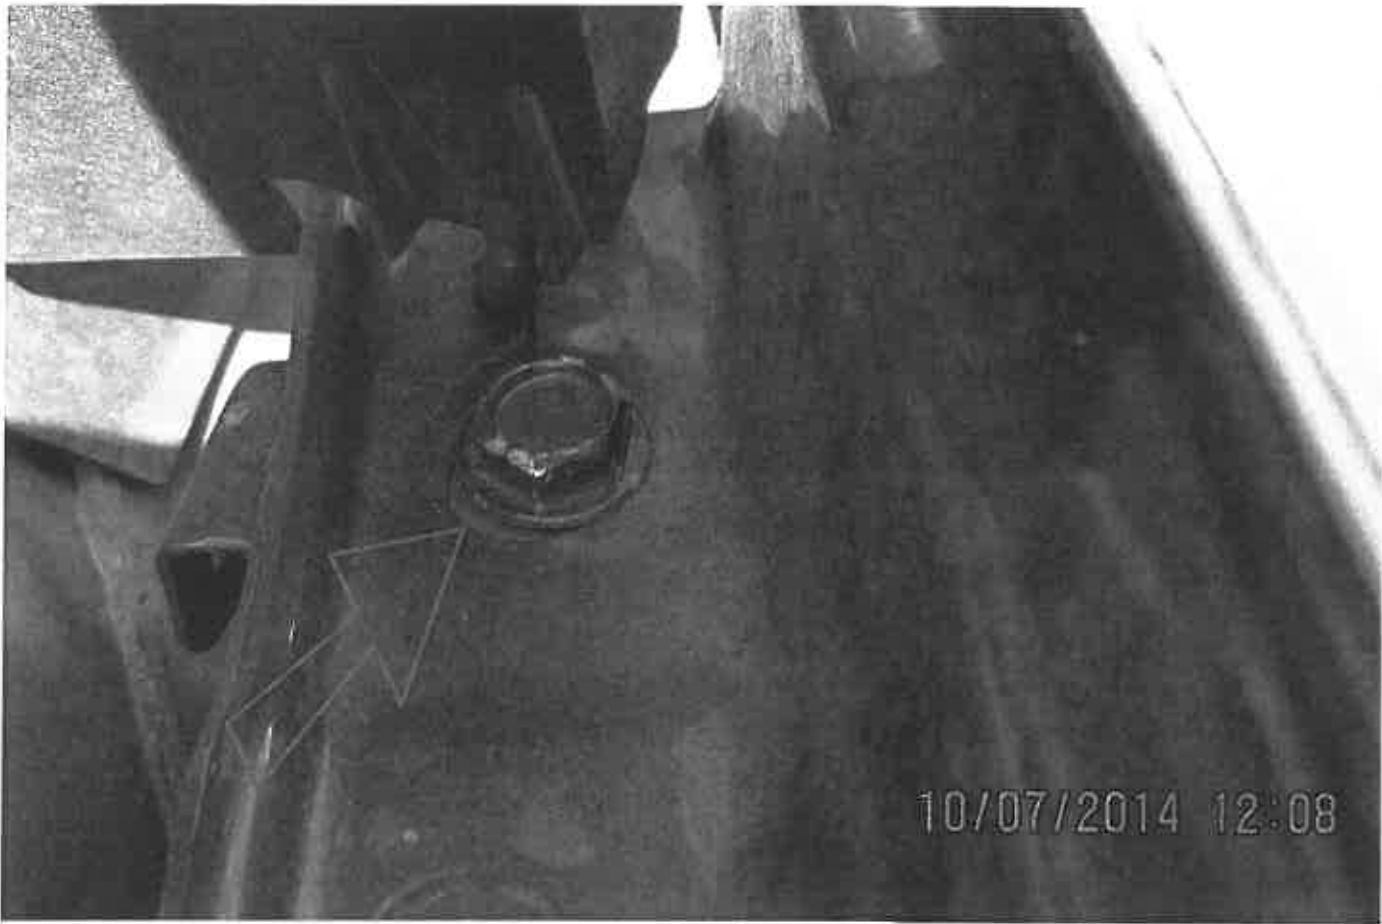
The above image shows the rear-most left fender mounting bolt. One can easily see that the hole in the fender flange had to be relieved in order to install the bolt. This is indicative of two things: that the car's structure is distorted, and that the repairer was aware there was something wrong with the car's unibody and took steps to conceal it from the customer/owner. This condition would have been obvious to anyone in the trade and should have triggered a more thorough investigation into its cause.

The structural damage and distortion noted in this report is serious in terms of where it manifests itself. That is, whenever one can see damage near to the cowl (firewall) of a vehicle, it shows the extent and severity of the front end damage. The distortion and damage in the left fender apron, the structural member to which the fender is bolted, was substantial enough to cause the fender bolt hole not be aligned with the mating threaded caged nut on the apron. The replacement fender's rear-most bolt hole had to be relieved in order to be installed on the distorted inner structure. The collision energy traveled the length of the apron.

The structural damage noted on the left front apron is the result of two (2) separate collision events. This fact will increase the tendency for the structural component to deform that much more readily than an undamaged vehicle would. The unibody, also known as the frame was compromised by the collision damage. Clearly this distortion is outside the accepted tolerances in the repair industry, even the generous 3mm standard the used car business will go by. The distortion is 6-8 mm.
